**EFFECTS OF GEOMORPHIC PROCESSES AND LAND USE  
ACTIVITIES ON SLOPE STABILITY IN MOUNT ELGON REGION,  
EASTERN UGANDA**

A thesis submitted in fulfilment of the Degree of Doctor of Philosophy in the  
School of Humanity and Social Sciences of Kenyatta University

NOVEMBER 2014

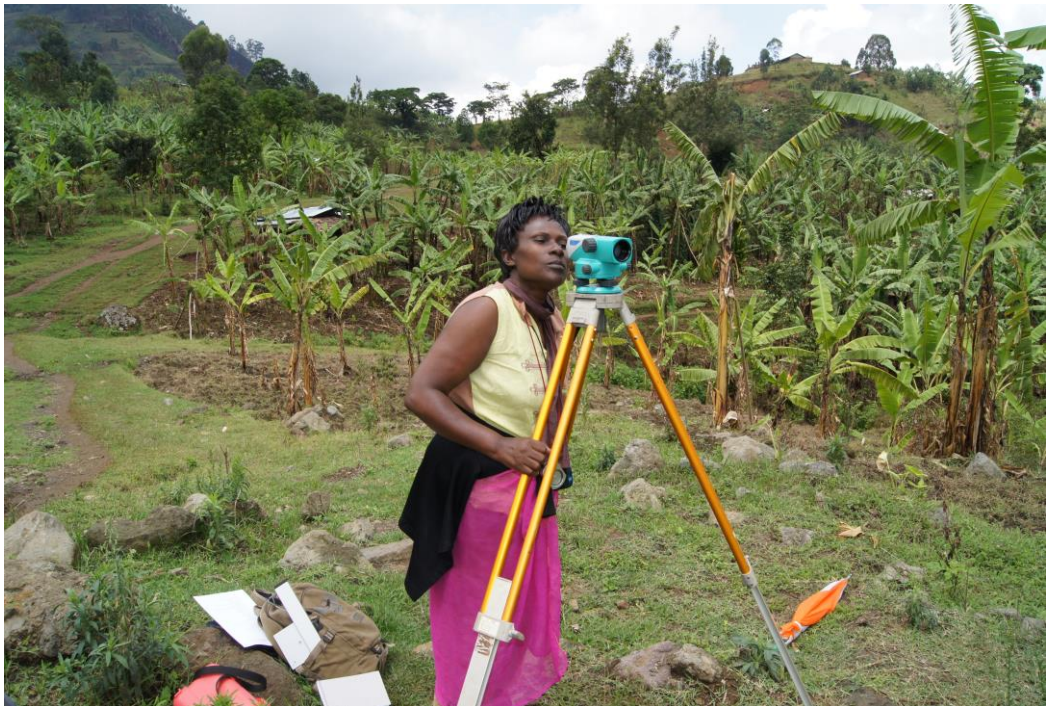
Geographic coordinates of the location of past and recent evidences of slope instability were recorded using a GPS 76. This yielded measurements of 35 landslide scars and 2 tensional cracks which formed the sample sites. Slope angles of sites below the landslide scars were measured and recorded using a dumpy level theodolite while those above and around the scar were by a Santos clinometer (**Plate 3.1**). The computed measurements were recorded as part of item number three of the proforma checklist (**Appendix 3.3**).

**Plate 3.1:** Measurement of slope angle below a landslide scar  
(Bukhalasi- Bududa, May 2010)

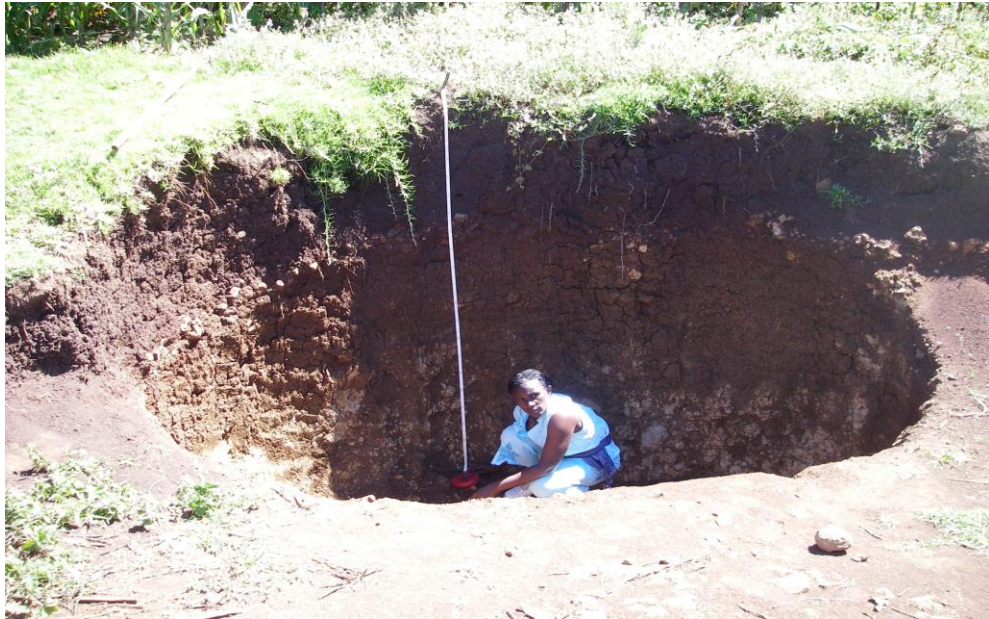
Soil profiling was done in different areas so as to determine regolith depths at different slopes confirmed to be vulnerable to slope failure. Soil profile pits ranging from a minimum of 50 centimetres to a maximum of 300 centimetres depths were dug near each of the studied scars so as to establish the existing soil layers and consequently determine their successive depths (**Plates 3.2, 3.3**) and **Appendix 3.4**. Measurements taken were recorded in the proforma checklist (**Appendix 3.3**).

**Plate 3.2:** A one and a half metres deep soil profile pit  
(Baaya-Manafwa, December 2009)

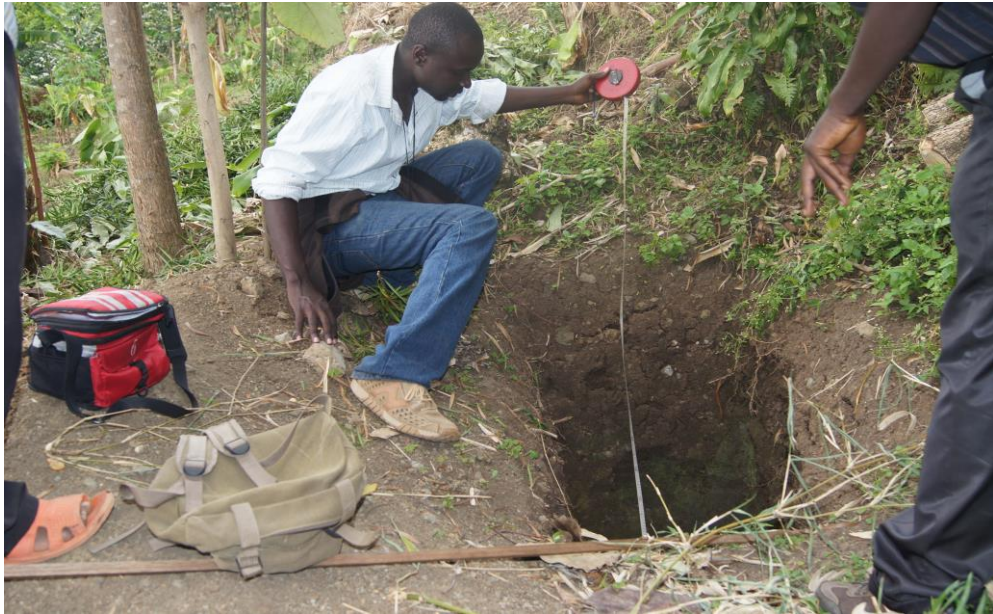
**Plate 3.3: A three metres deep soil profile pit (Maboono- Bududa, October 2009)**

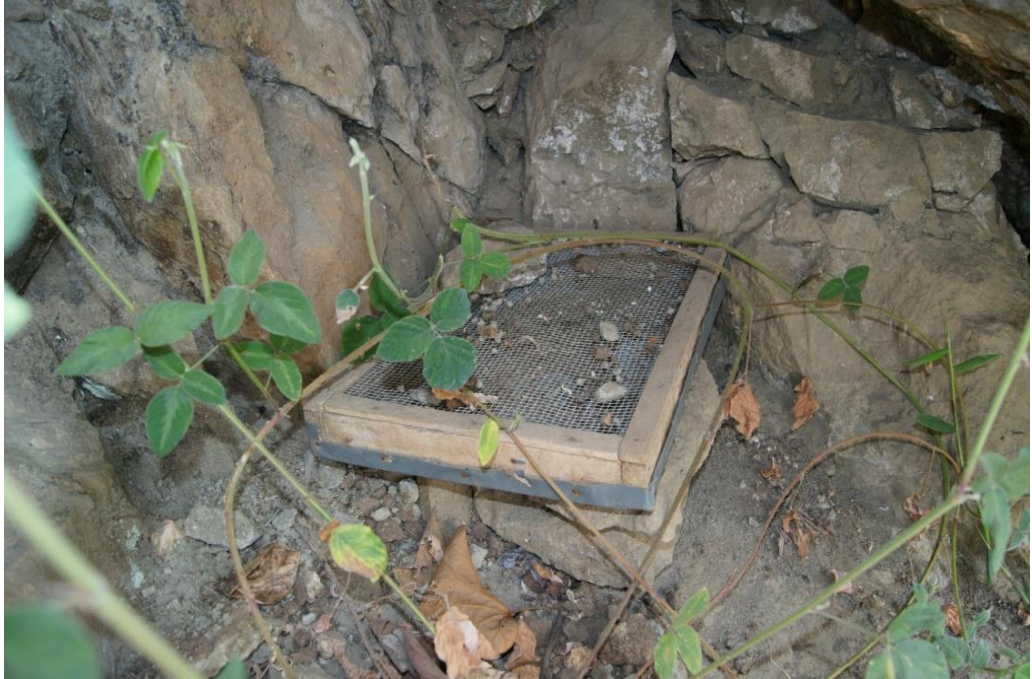
Rock fall rates were determined by assessment of frequency and magnitude of the process. This was measured by placing a trap made of a carpet and a wire netting of 10mm mesh at the foot of a free face (**Plate 3.4**). The amount of debris that was trapped every 28<sup>th</sup> day of the month over a period of one year from March 2009 to February 2010 was respectively measured, recorded and then later plotted against cumulative dates so as to be able to determine the rate of movement and periods of relative slope stability.

**Plate 3.4:** A wire mesh trap placed at a cracked scarp face on Nkokonjeru ridge (Bumboi – Mbale, 28<sup>th</sup> December 2009)

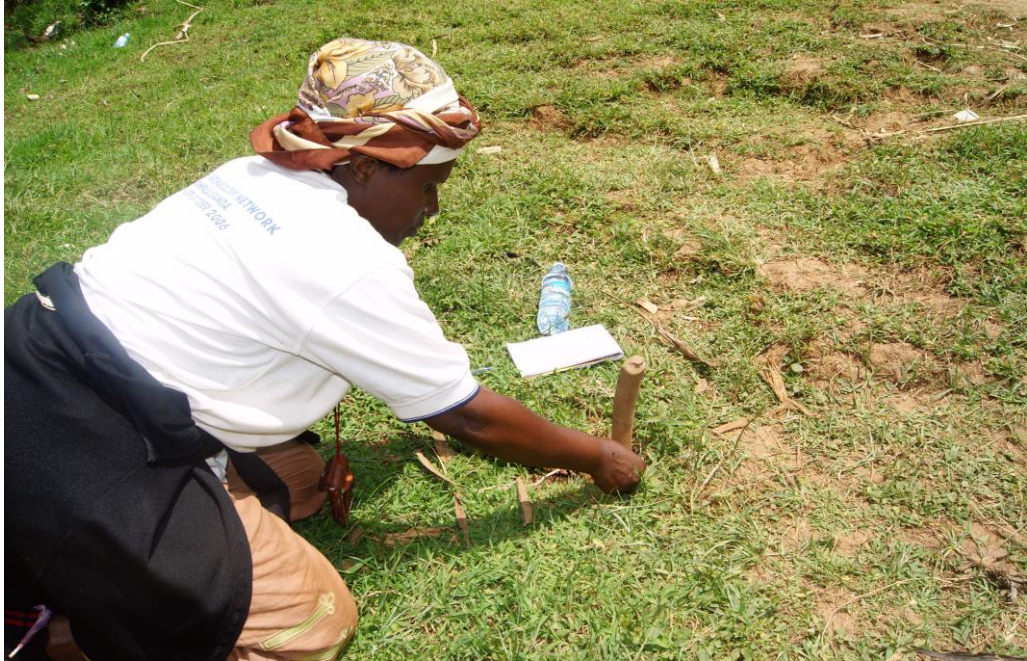
Further stability analysis was done by determination of distribution of areas subject to slope instability. A Clinometer was used to make slope angle measurements as well as the equivalent percentage gradient. This was done by measuring slope angles whose slope gradient was computed according to three categories of likelihood of hazard occurrence namely; less than 30%, between 30-60% and greater than 60%. This helped to predict hazard occurrence by rating areas with low, moderate, or high slide potential.

**Plate 3.5: Peg displacement measurement to detect likelihood of slope failure (Bukhalasi – Bududa, March 2009)**

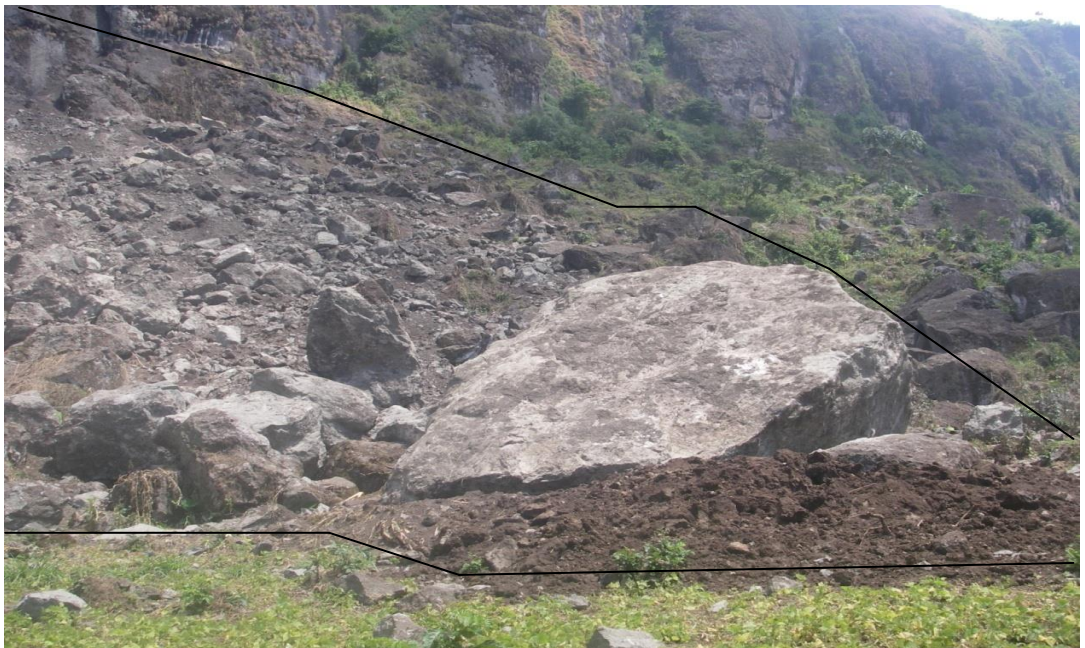
**Plate 4.1:** Rocks from a collapsed rock face on Wanale scarp (Mbale 2009)

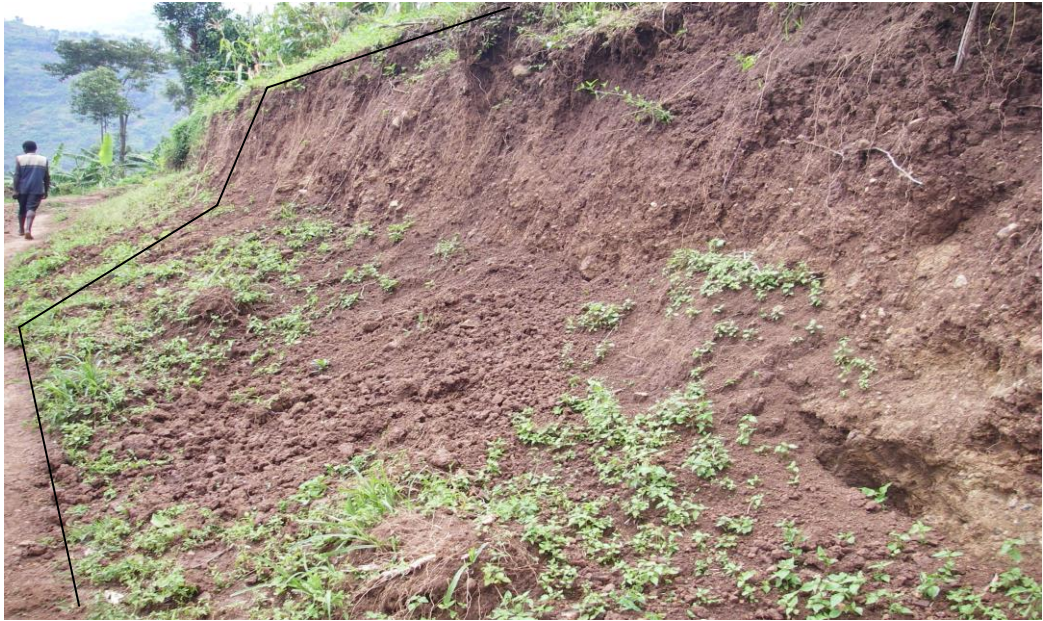
**Plate 4.2.** All the three categories of falls that have been experienced in Mount Elgon were established to be surficial because they affected the upper most layer of the regolith (0.2-0.8 metres depth) on the debris slope where the boulders, pebbles, rock fragments or soil passed and eventually accumulated.

**Plate 4.2: An earth fall experienced on a road side cutting in August 2009 (Bufupa 24<sup>th</sup> November 2009)**

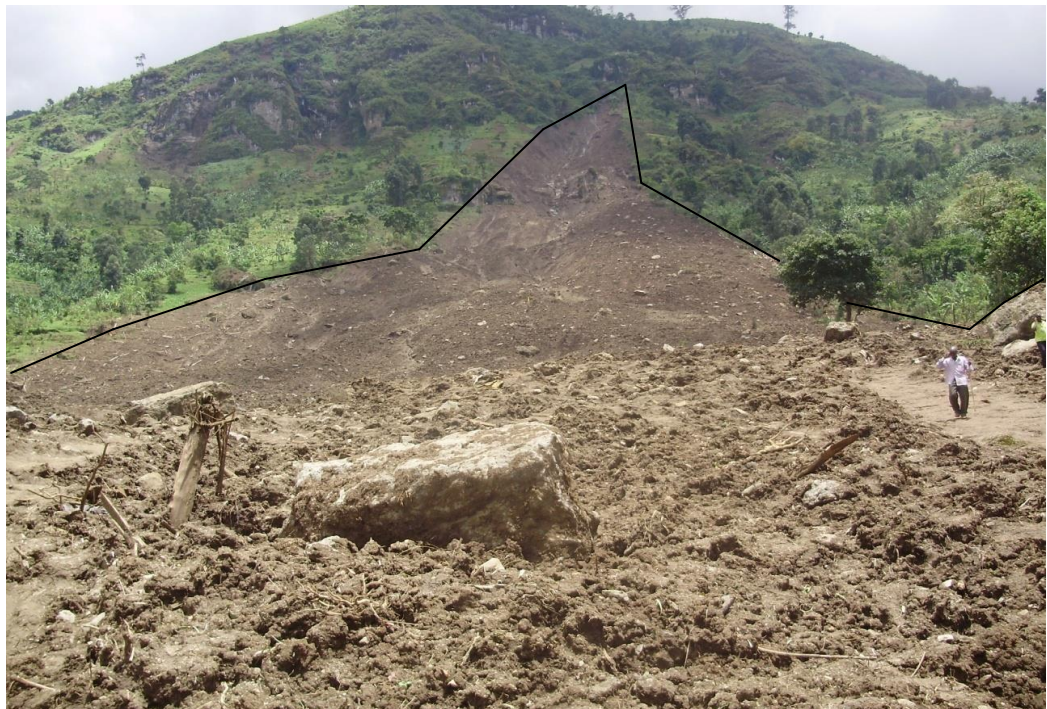
**Plate 4.3:** A rotational slump of 2nd March 2010  
(Namesti 23<sup>rd</sup> March 2010)

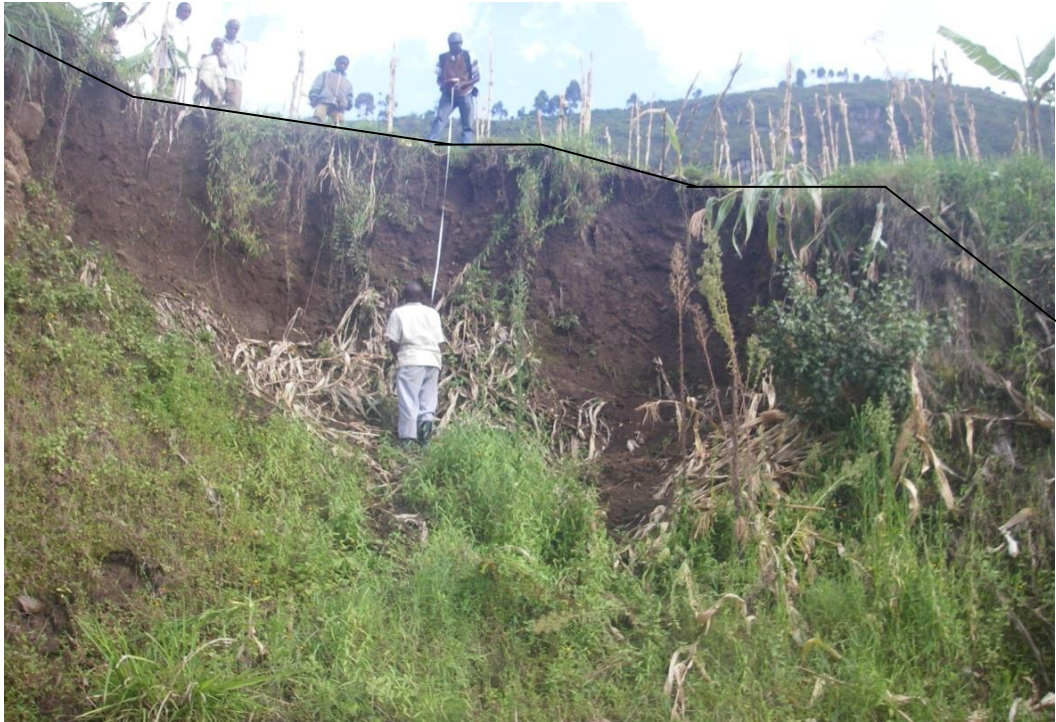
**Plate 4.4: A translational slide of August 2008  
(Bukinyale 23<sup>rd</sup> November 2009)**

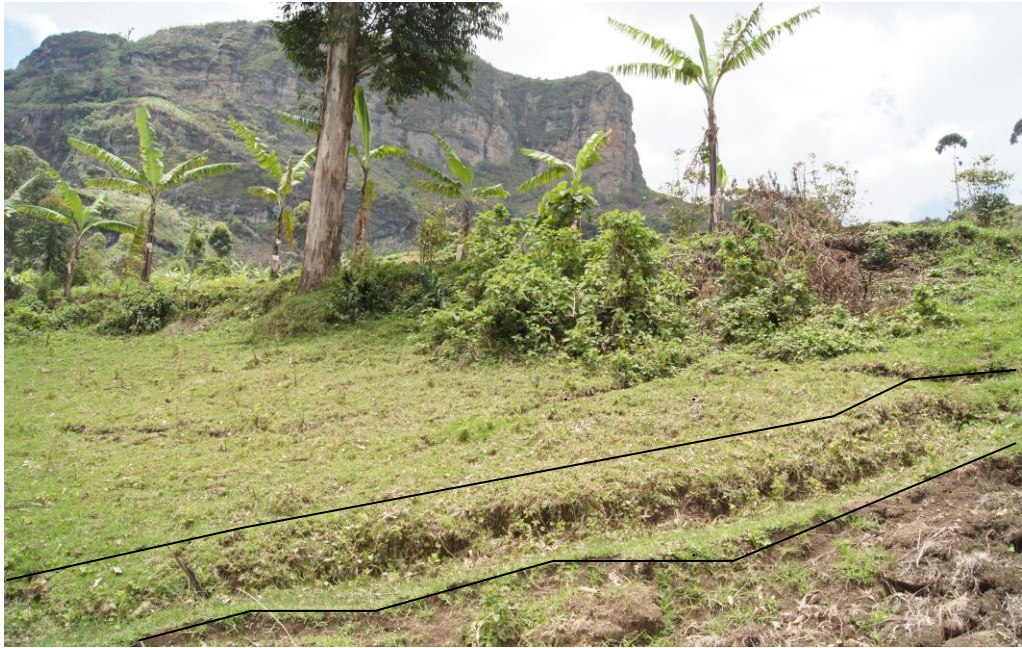
00°55'08.3"N, 034°22'43.5"E in Bukwapa village and 00°57'35.9"N, 034°22'24.9"E in Tsekululu and Bumbo in Manafwa district (**Plates 4.5a, 4.5b and 4.5c**). The crack at Buwere was 80cm wide on 28<sup>th</sup> May 2010 while the one at Bukwapa was 30cm wide on 30<sup>th</sup> May 2010. These cracks are believed to be part of a continuous crack that cuts across Mount Elgon westwards from River Lwakhakha at the border with the republic of Kenya through the districts of Manafwa, Bududa, Mbale, Sironko and North West wards through Kapchorwa.

**Plate 4.5a: A tension crack cutting across the top of Namisindwa ridge (Buwere 28<sup>th</sup> May 2010)**

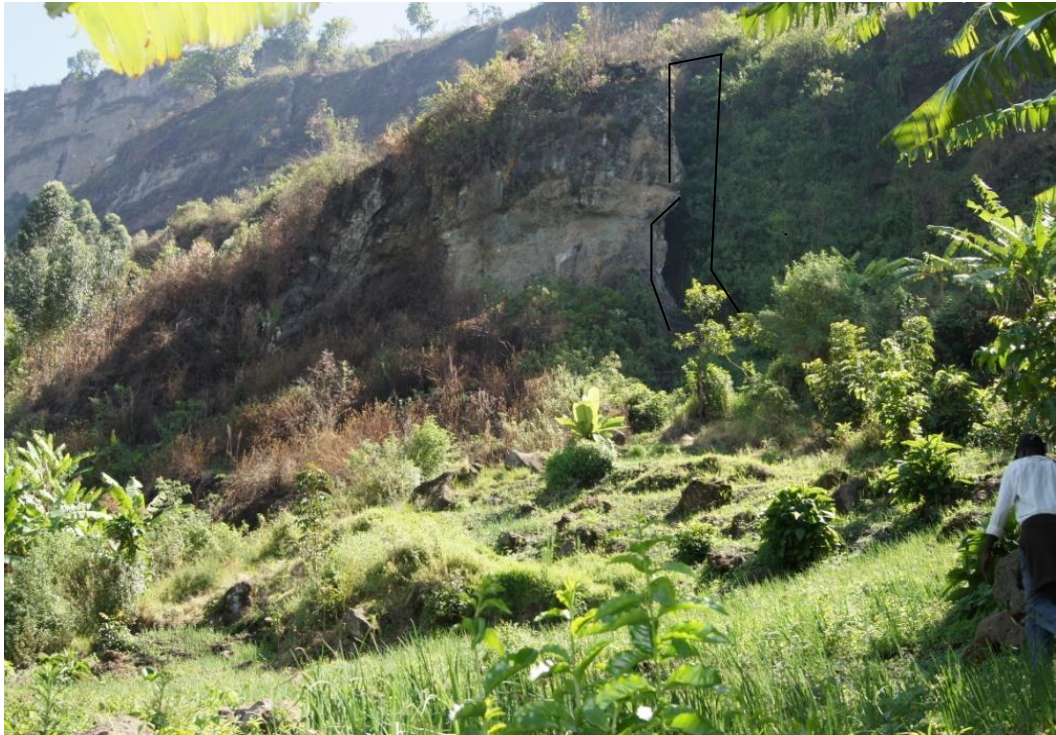
**Plate 4.5b: A tension crack cutting through Namisindwa ridge Scarp (Bukwapa 30th May 2010)**

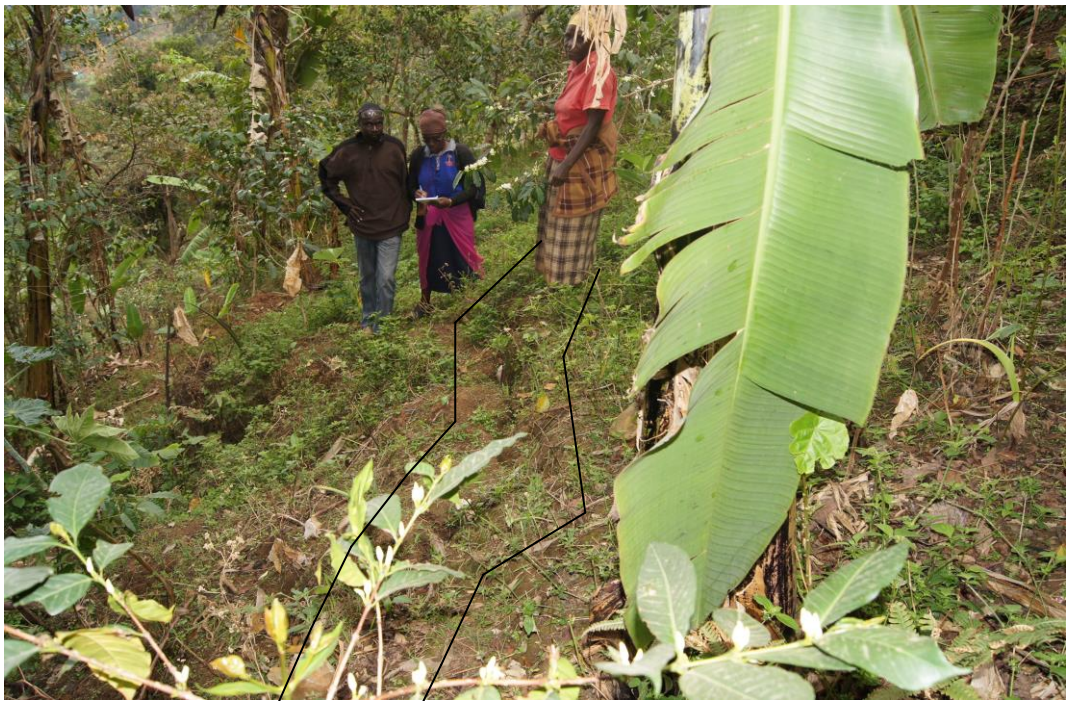
**Plate 4.5c: A tension crack cutting across Tsekululu hill (Bunambale May 2010)**

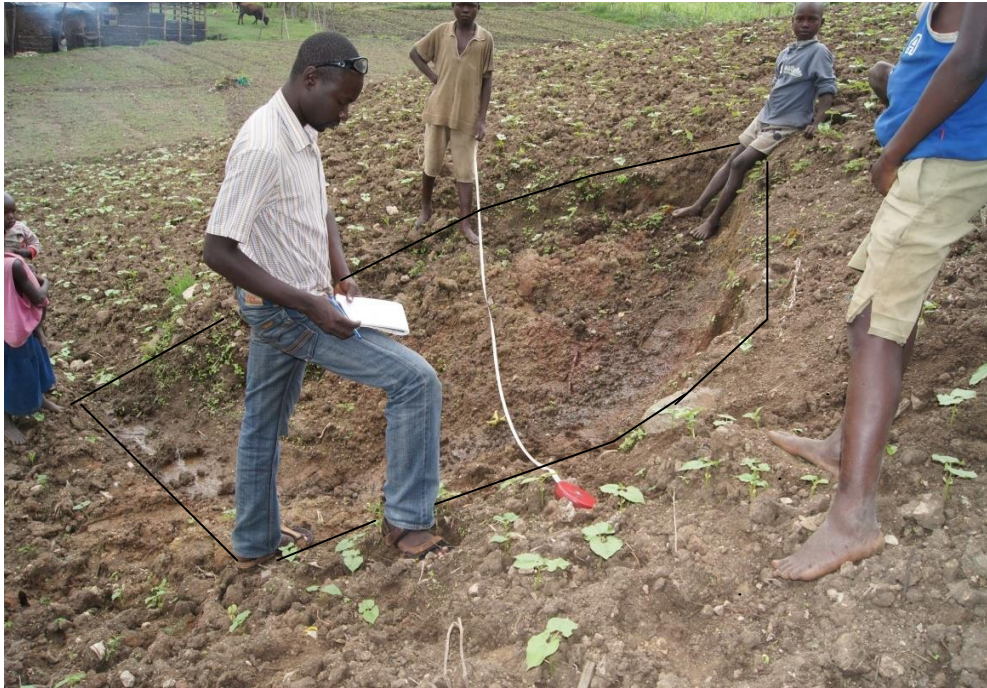
Pot holes which are sunken parts of the ground associated with the same kind of tensional forces were also spotted in Bumbo sub-county in Bwandhiambi village Manafwa district located at 00°53'21.4"N, 034°21'46.6"E and 00°53'22.2"N, 034°21'46.7"E. The former was established to be 0.7 metres deep while the latter was 3.8 metres as of 28<sup>th</sup> May 2010- **Plates 4.6 and 4.7.**

**Plate 4.6:** A sunken spot (pot hole) in a cultivated field planted with beans  
(Buwandiambi 28<sup>th</sup> May 2010)

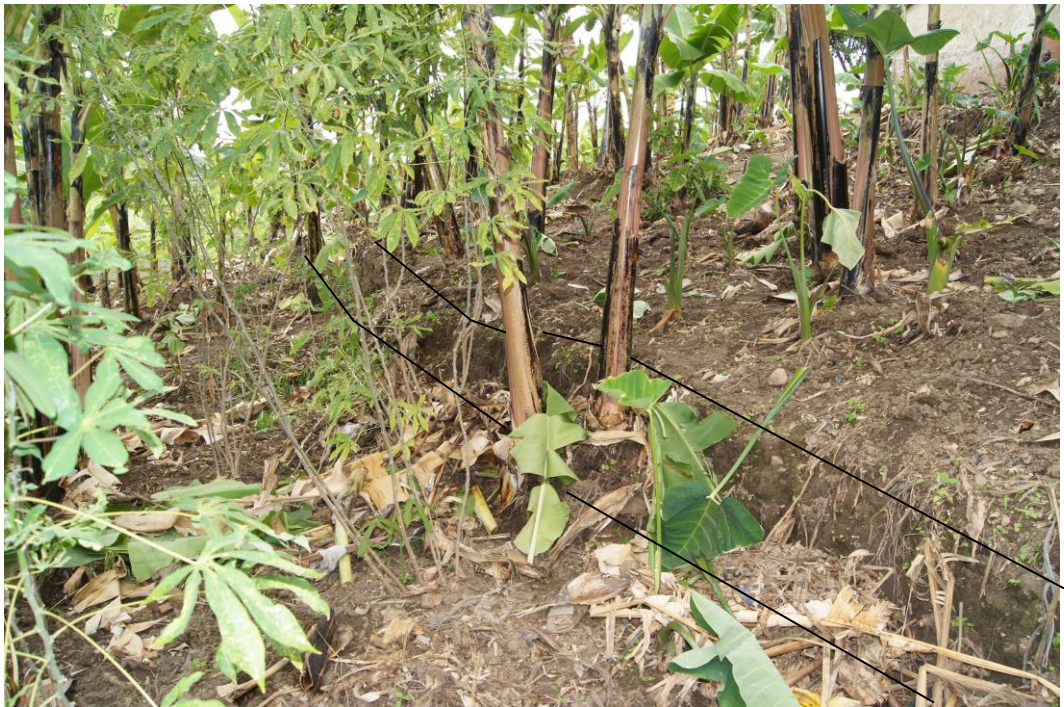
**Plate 4.7:** Part of a sunken spot in a banana plantation  
(Buwandiambi 28<sup>th</sup> May 2010)

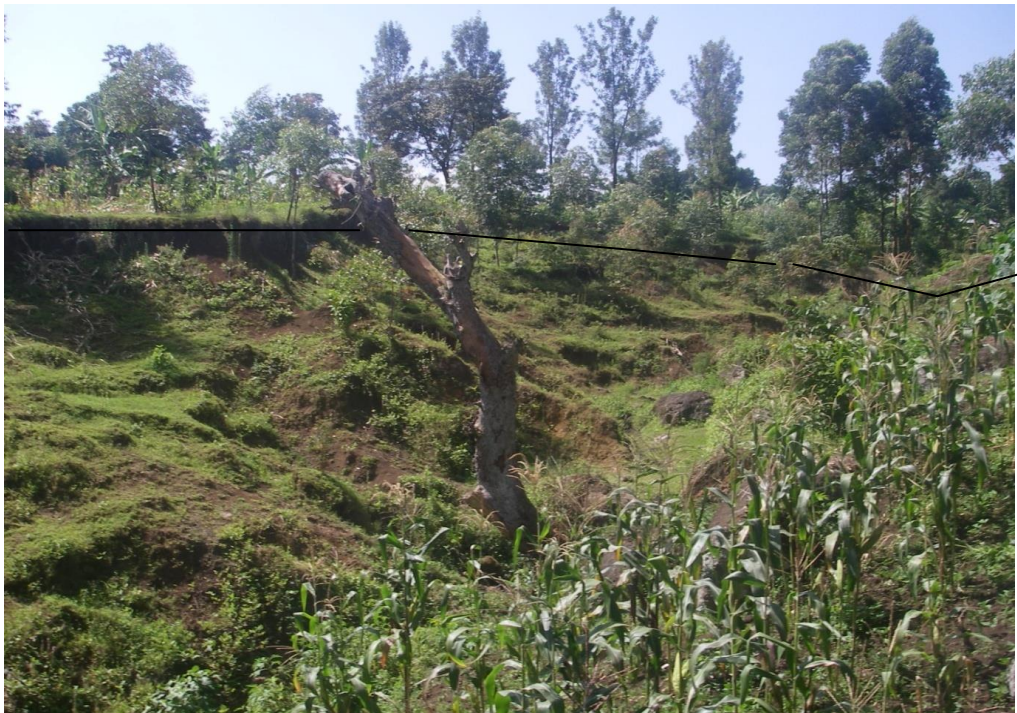
Associated with undermining of slope material by river undercutting is the effect of river bank wetting. The river at bank full discharge wets a larger perimeter of the channel than that wetted when discharge is at its lowest. These different bank wetting levels make the bank material heavy and it eventually collapses into the channel yet this removes support for the rest of material upslope which may also slide down slope into the river valley. Such incidences were noted to have occurred in Bumadanda and Jewa in Bufumbo-Mbale district – **Plate 4.8**. Evidence of such effects was landslide scars located along river valleys.

**Plate 4.8:** A Landslide scar of August 2008 cutting along Nabuyonga stream channel

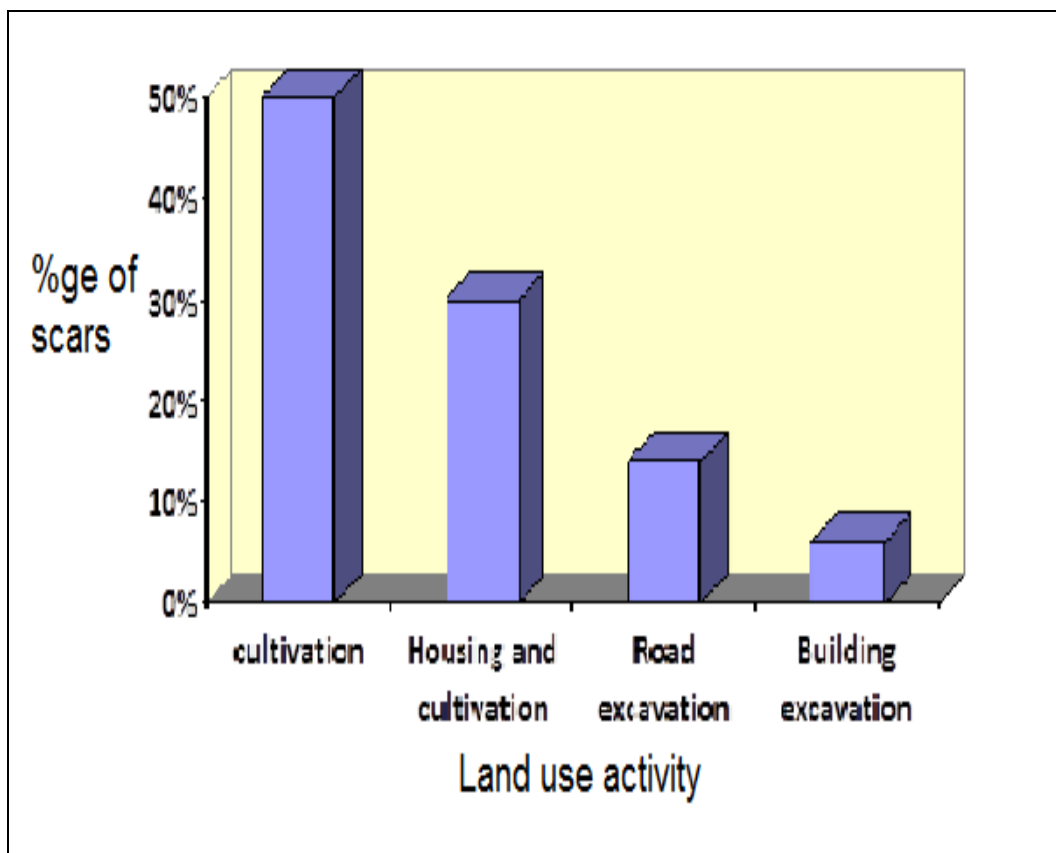
Analysis of the 36 landslide scars surveyed revealed that 18 occurred on cultivated fields, 11 occurred where there was housing and cultivation, and 5 took place along road cuttings while 2 were exclusively on excavated housing grounds. The distribution of land slide scars according to land uses that were being practiced by the time the landslides occurred is depicted in **Figure 4.3**.

**Figure 4.3: Slope instability associated with different land use activities practiced in Mount Elgon**

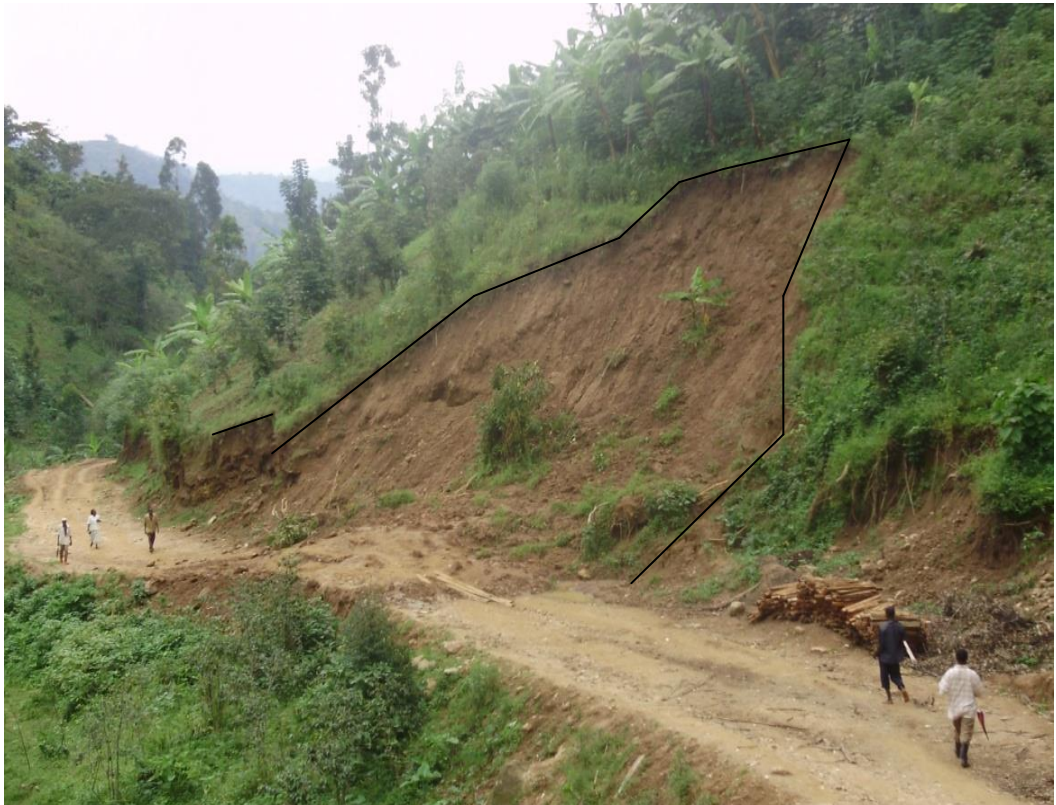
given any other form of protective cover. This was commonly observed on feeder roads that cut through the steeply inclined parts mostly at 70% and above in Bunandutu in Bududa district and Moni in Mbale district.

**Plate 4.9: Slope failure experienced along Bukhalasi-Namesti road on 4<sup>th</sup> March 2010 (Bukhalasi 23<sup>rd</sup> March 2010)**

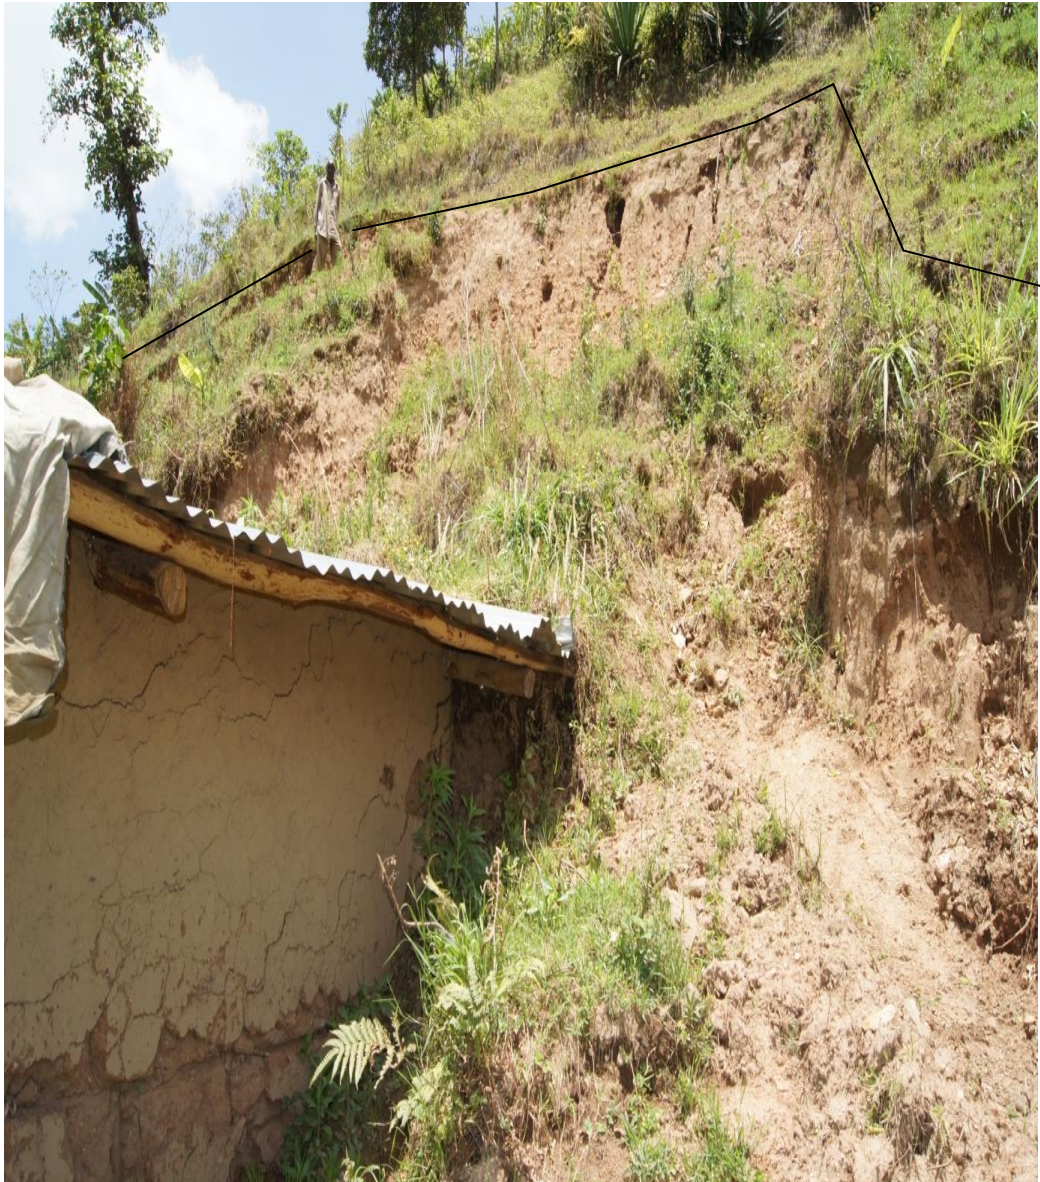
Some buildings were further observed to have caused the ground upon which they are constructed to crack due to overloading of the steeply inclined slopes. This was found common on slopes inclined at  $30^{\circ}$  and covered with shallow loam-clay soils. Such buildings exert a lot of pressure on the shallow and often saturated regolith which developed cracks and eventually assumed a down slope flow as shown in **Plate 4.10**.

**Plate 4.10: Slope failure triggered by undercutting by housing construction (Maboono July 2010)**

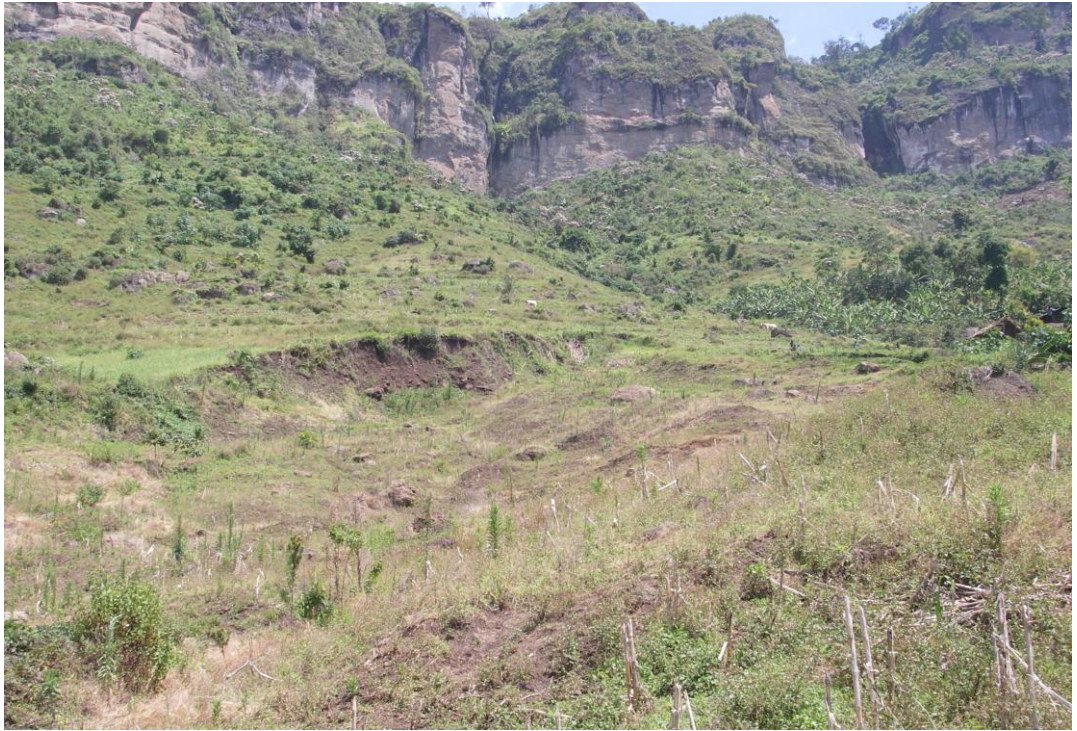
**Plate 5.1:** A slope segmented into the scarp, debris slope and the pediment slope at the bottom  
(Bumbo August 2009)

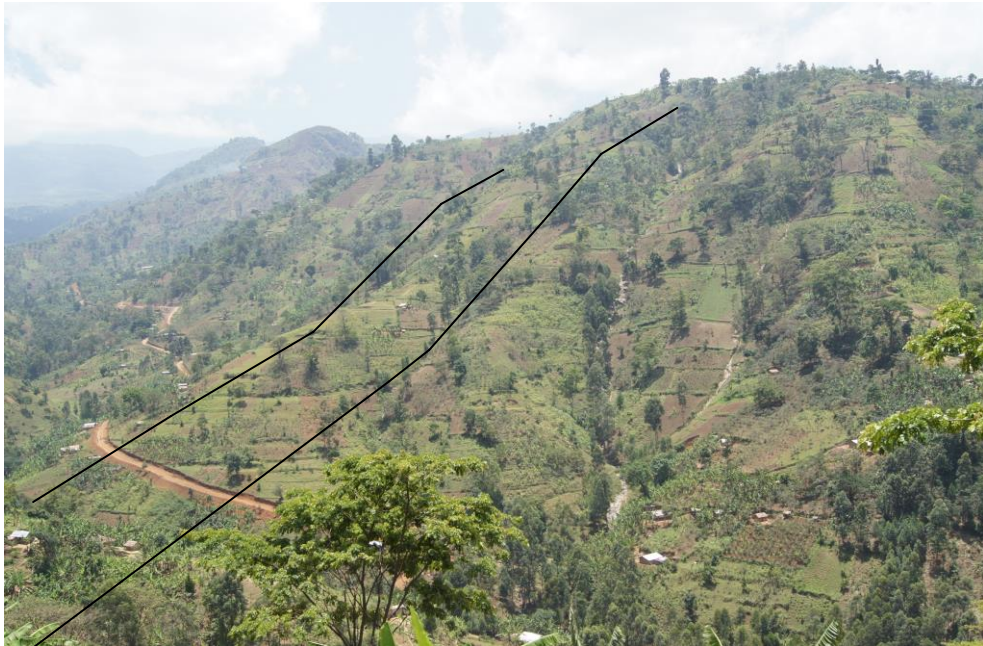
**Plate 5.2:** Rectilinear slopes composed of lower concavities and upper convexities  
(Maboono December 2009)

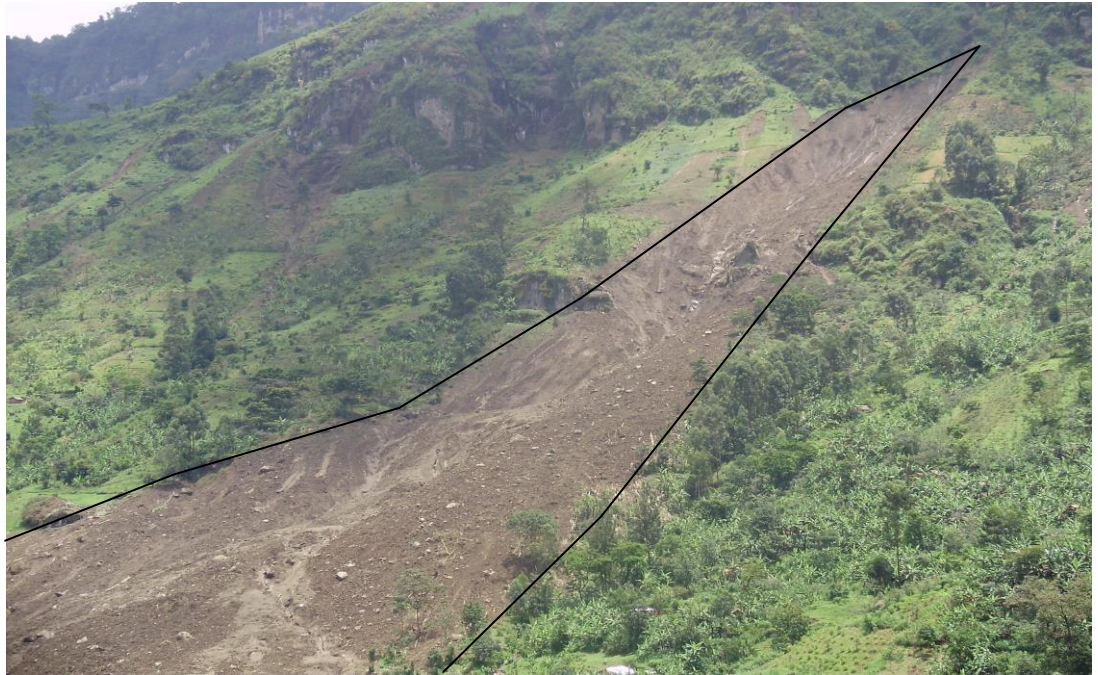
**Plate 5.3a: A landslide scar initiated at a spot on the upper steep concave slope in 2010  
(Bukhalasi March 2010)**

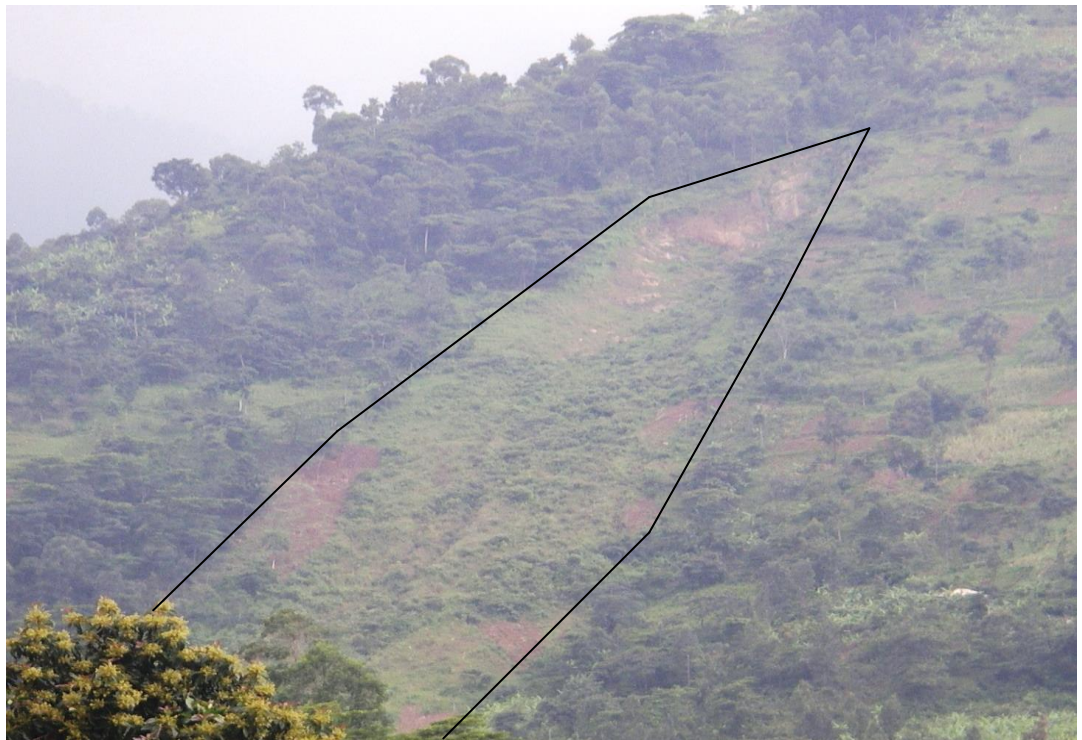
**Plate 5.3b: A landslide scar initiated on the steep upper concavity of a slope in 1998  
(Buwali December 2009)**

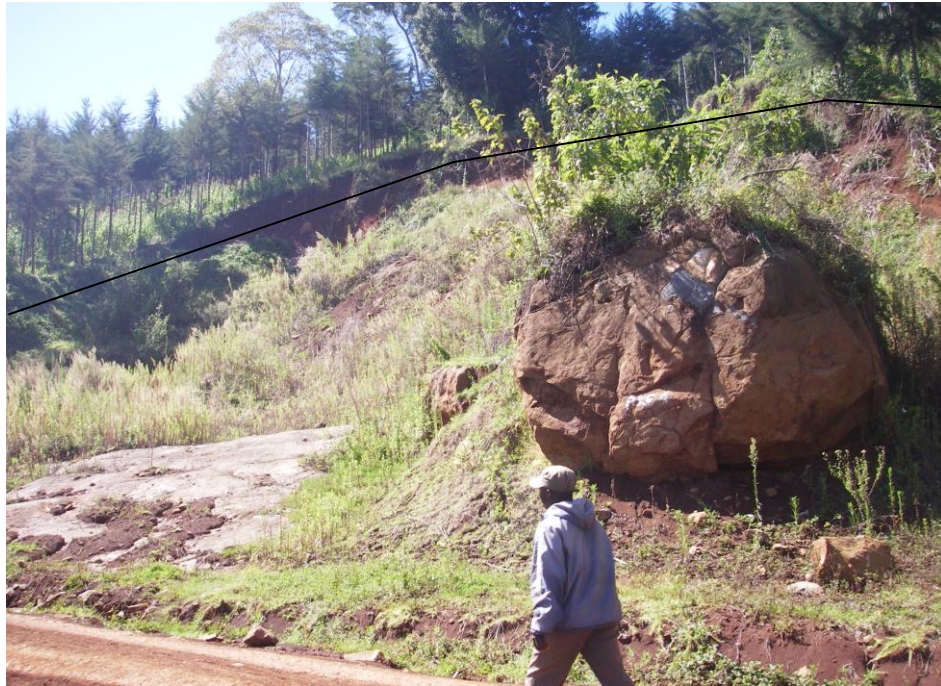
**Plate 5.4a:** A land slide scar by the road side initiated on the upper convexity of a slope  
(Bukhalasi December -2009)

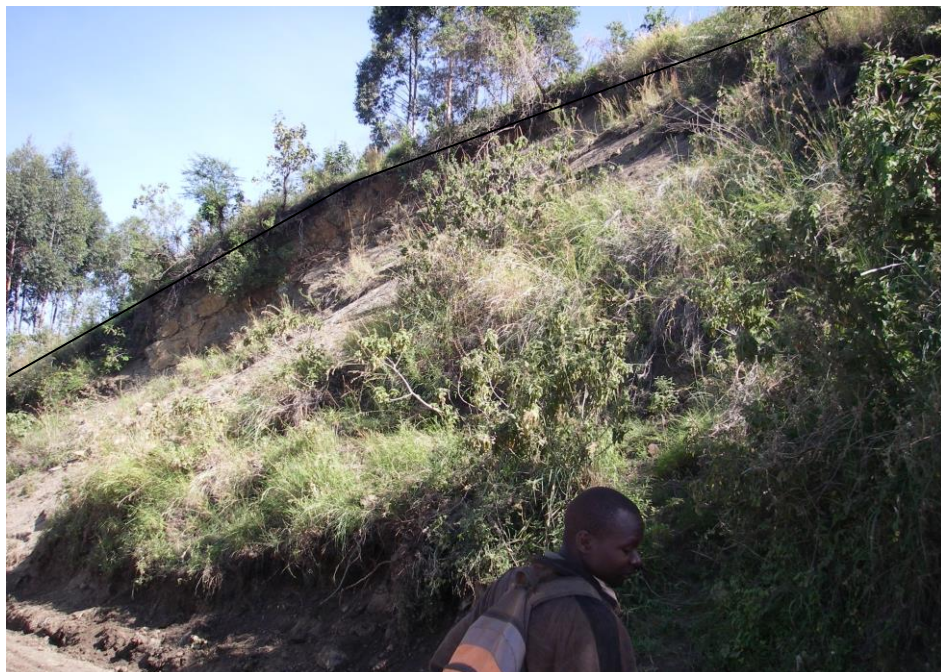
**Plate 5.4b:** A land slide scar initiated by the road side on the upper convexity of a slope  
(Bufupa - November 2009)

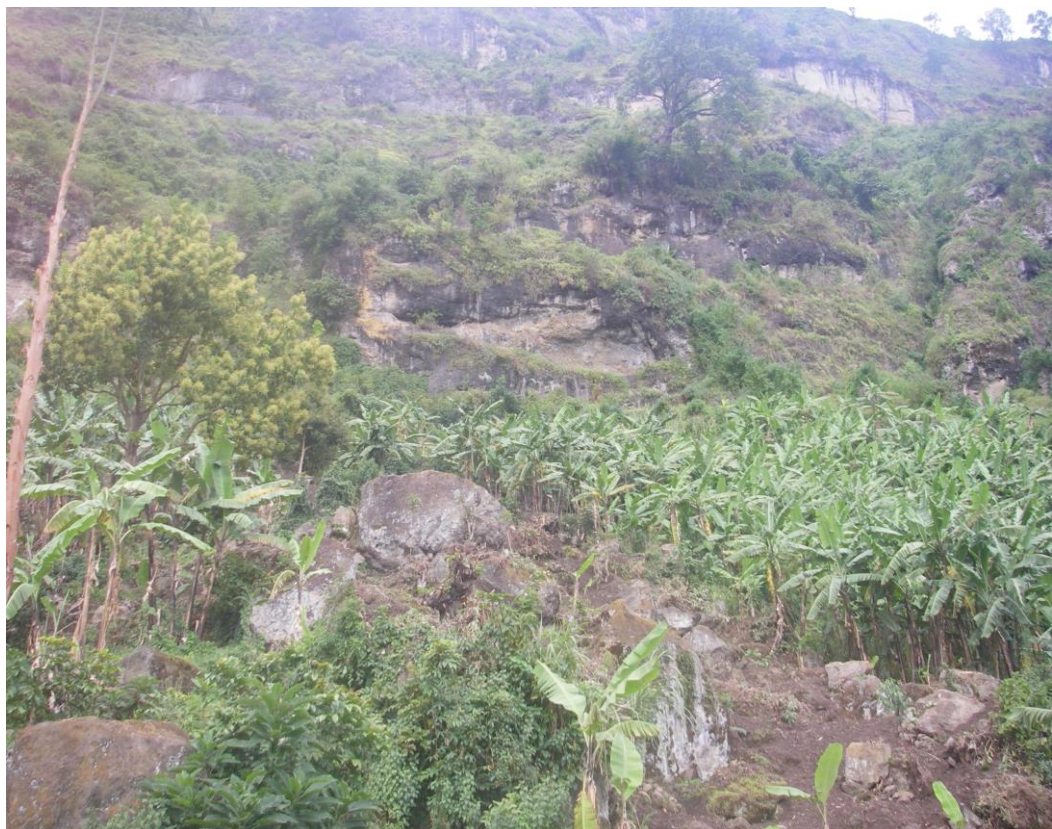
**Plate 5.5a: A debris slope vulnerable to rock fall from an adjacent scarp face (Namudongo- December 2009)**

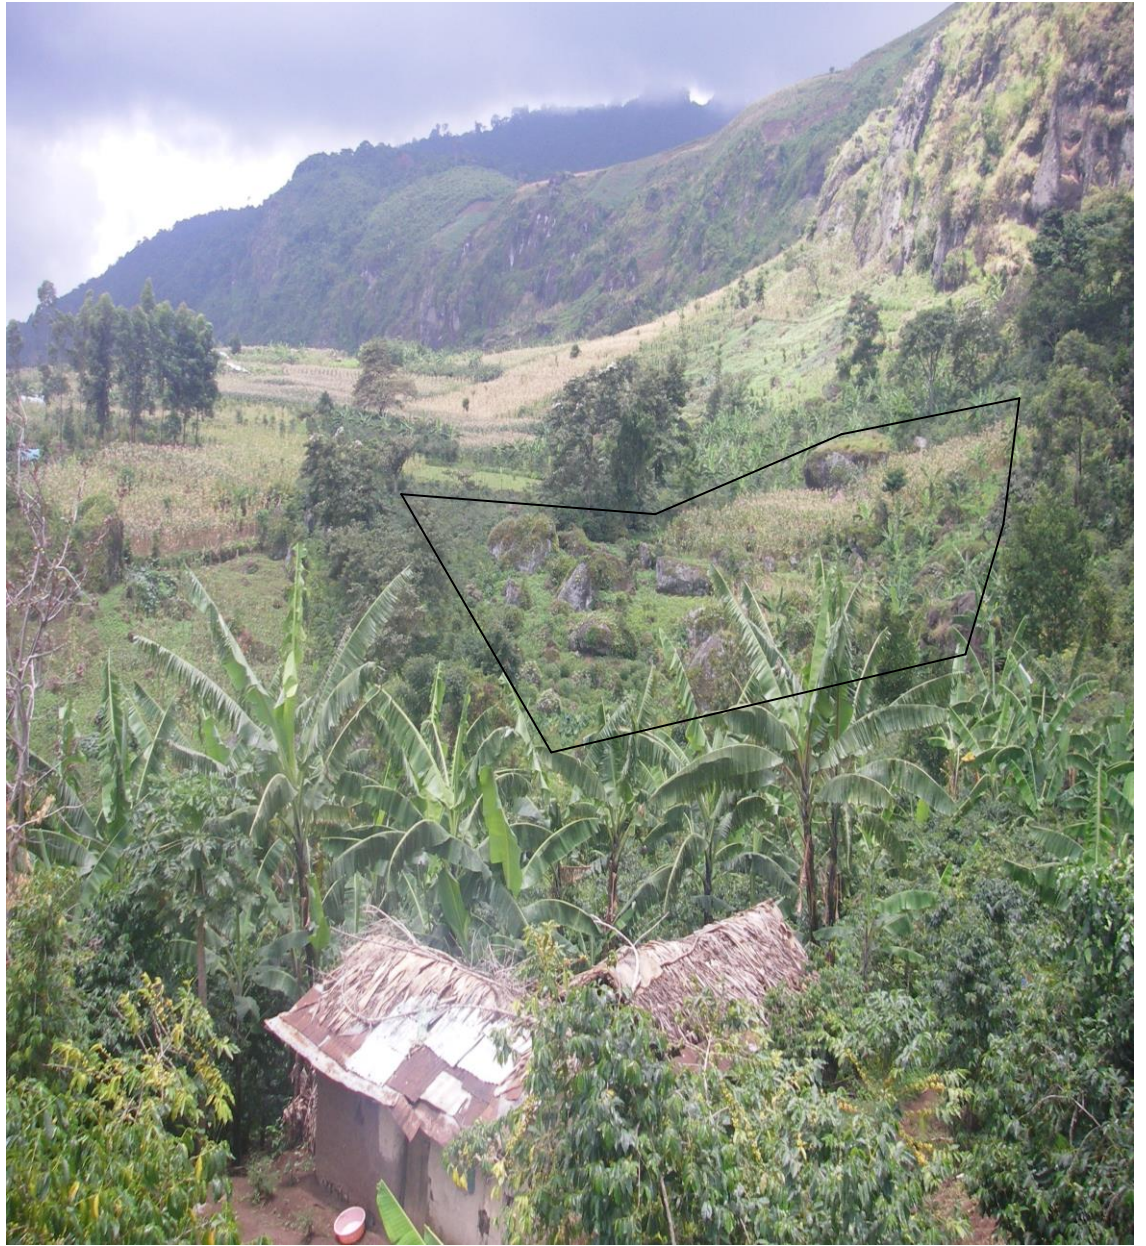
**Plate 5.5b: Pebbles that collapsed from the scarp face in the right middle ground heaped on the pediment slope (Namudongo- November 2009)**
