**EFFECTS OF GEOMORPHIC PROCESSES AND LAND USE  
ACTIVITIES ON SLOPE STABILITY IN MOUNT ELGON REGION,  
EASTERN UGANDA**

A thesis submitted in fulfilment of the Degree of Doctor of Philosophy in the  
School of Humanity and Social Sciences of Kenyatta University

NOVEMBER 2014

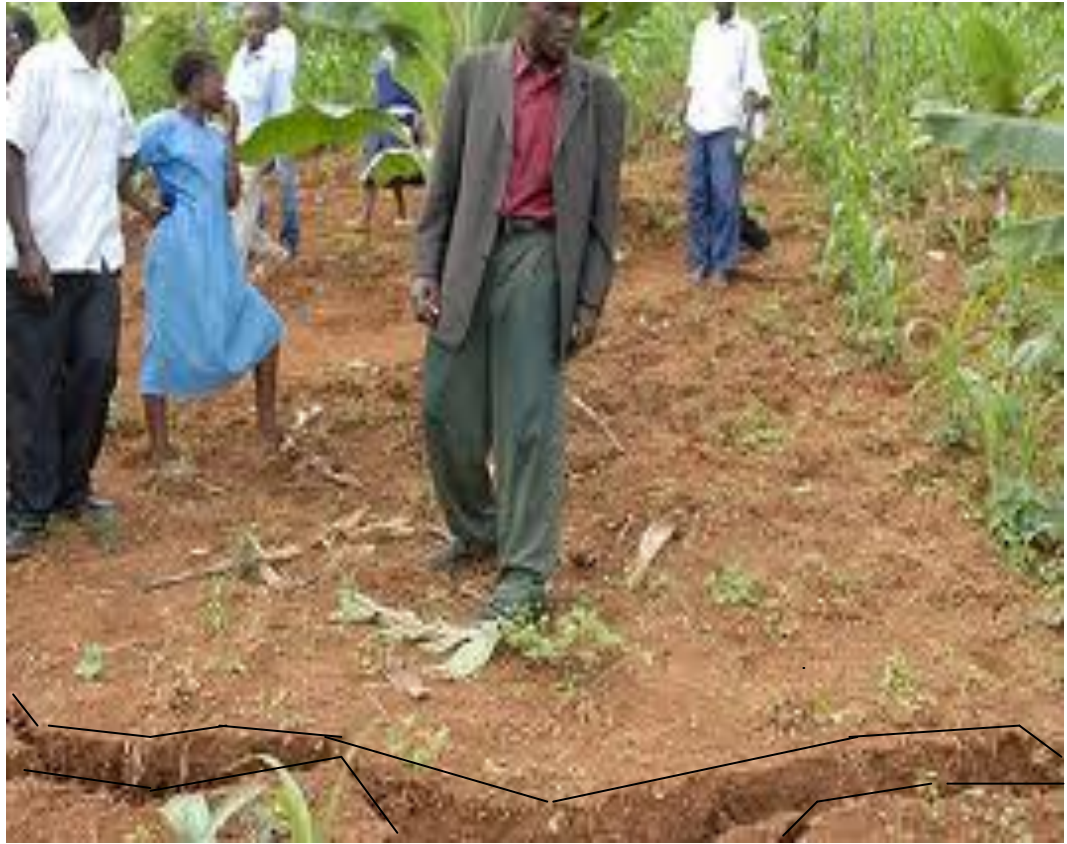
**Plate 6.1: Cracked ground associated with tension within regolith on a slope  
(Masira-April 2010)**

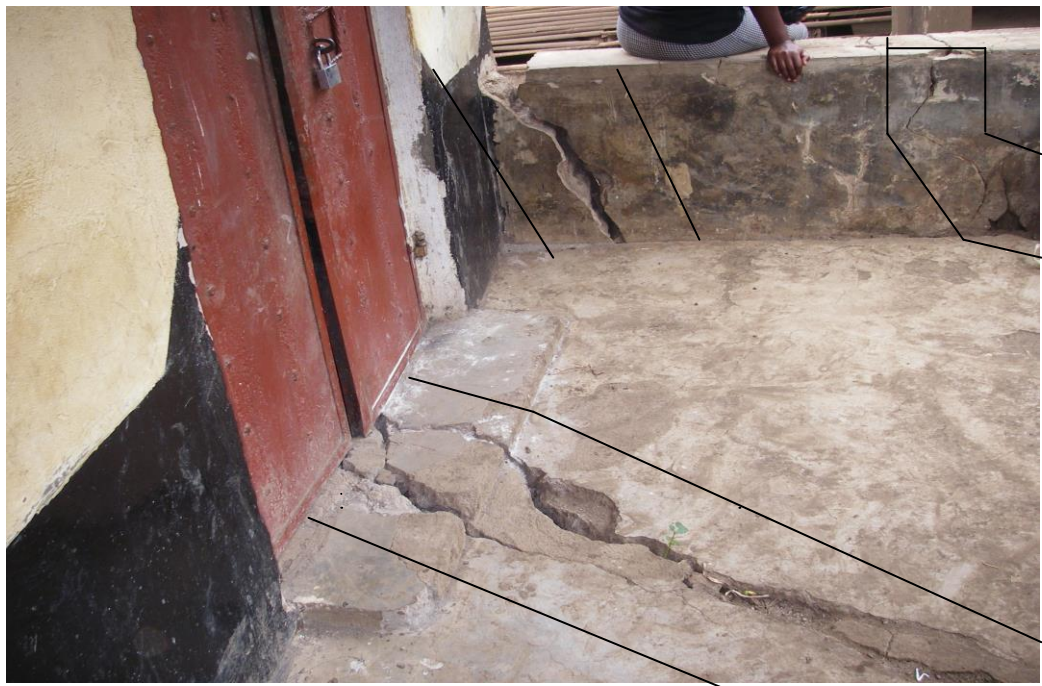
**Plate 6.2a: A cracked house veranda  
(Kibooko-August2009)**

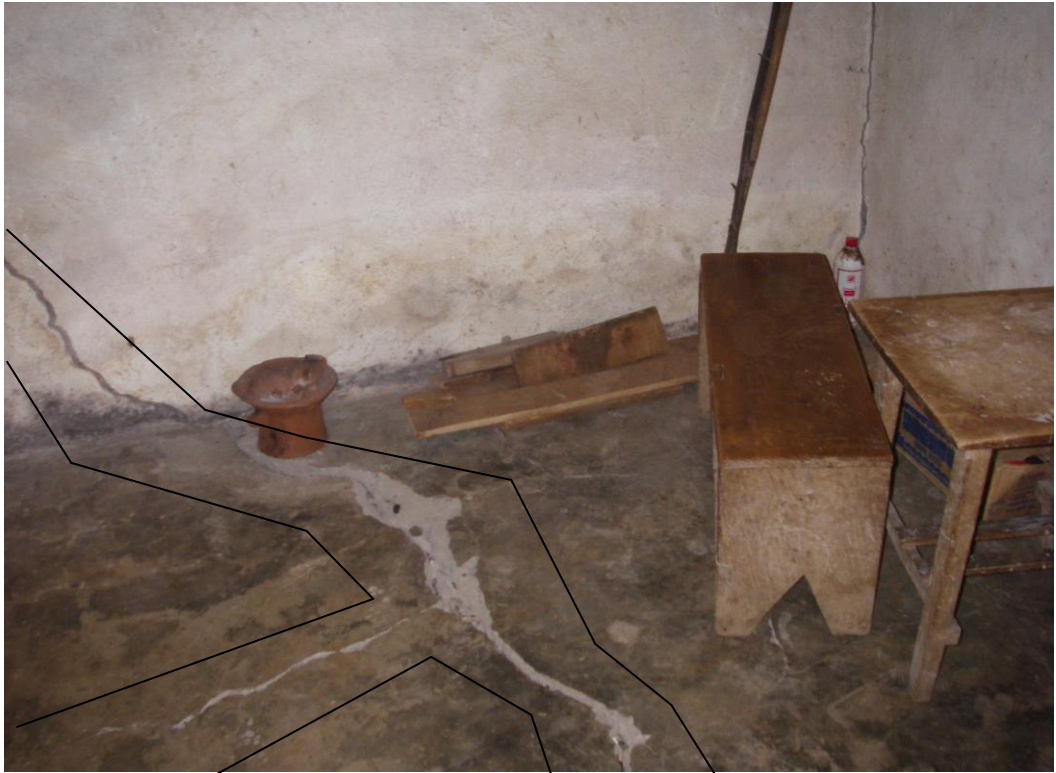
**Plate 6.2b: A cracked house floor Sironko (August 2009)**

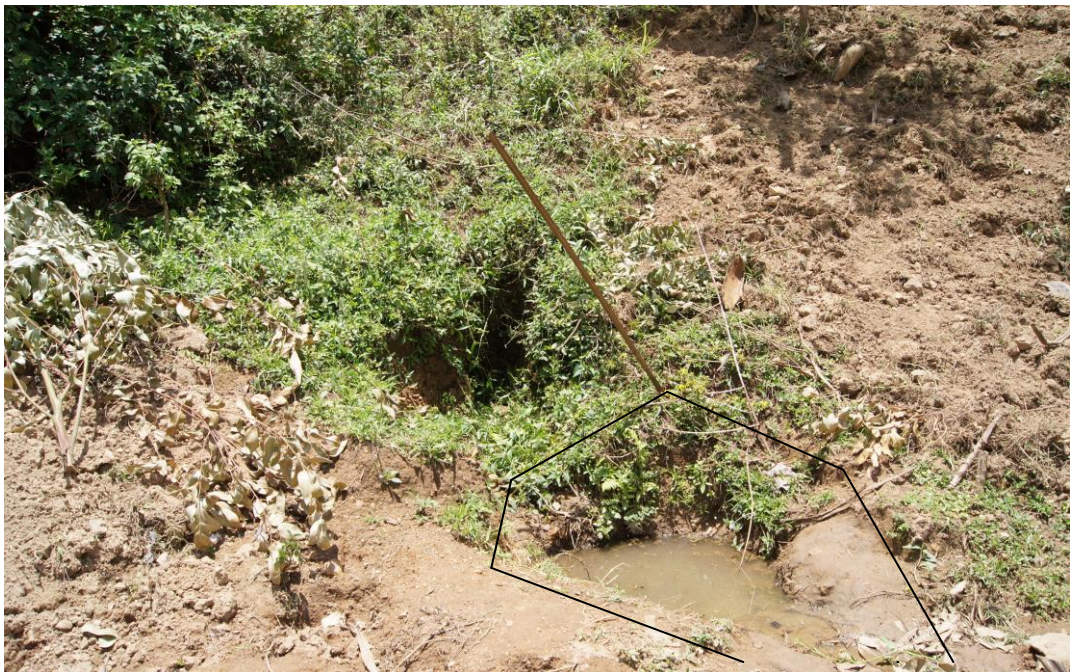
**Plate 6.3a: spot where groundwater emerges on to the surface (Maboono-April 2010)**

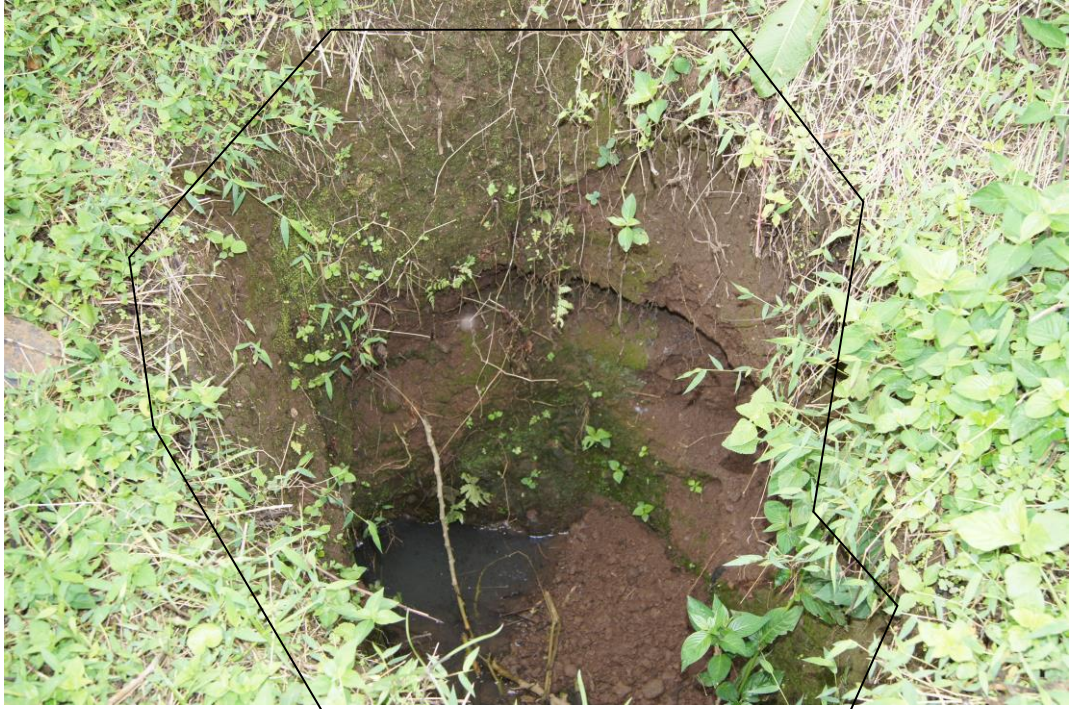
**Plate 6.3b:** A hole through which groundwater oozed out to the surface (Bukhalasi 2010)

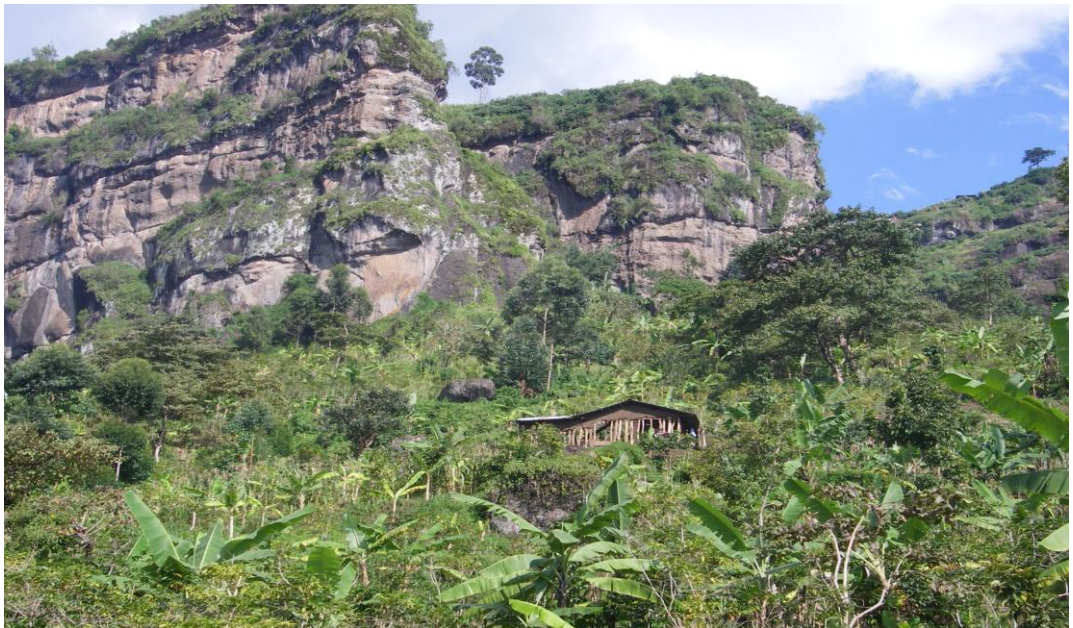
**Plate 6.4:** Cracked and dangerously hanging rocks on Zesui ridge that continuously roll down the scarp onto the debris slope (Sironko September 2009)

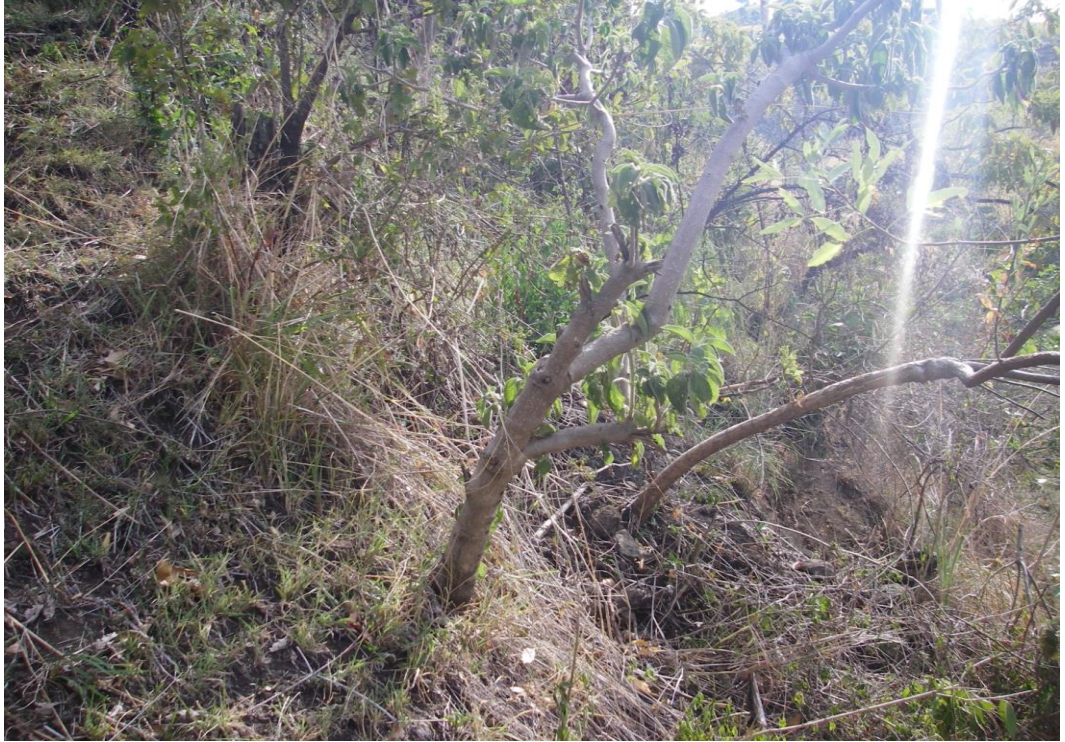
**Plate 6.5:** Tilted tree trunks due to large scale creep in Bumbo (Taaso August 2009)

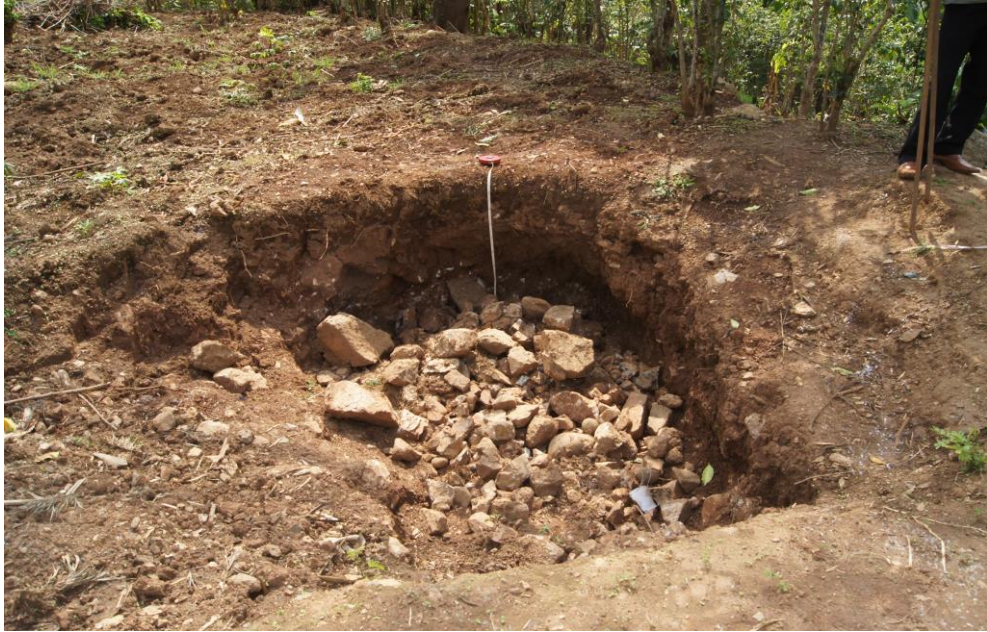
A ninety centimetres deep soil profile pit in Maduwa, Sironko District
