# Understanding the Environment, Promoting Health in Lake Baringo and Bogoria Drainage Basin

RIFT VALLEY LAKES-LEVEL RISE AND  
FLOOD CHALLENGES

Lakes Nakuru, Bogoria, Baringo

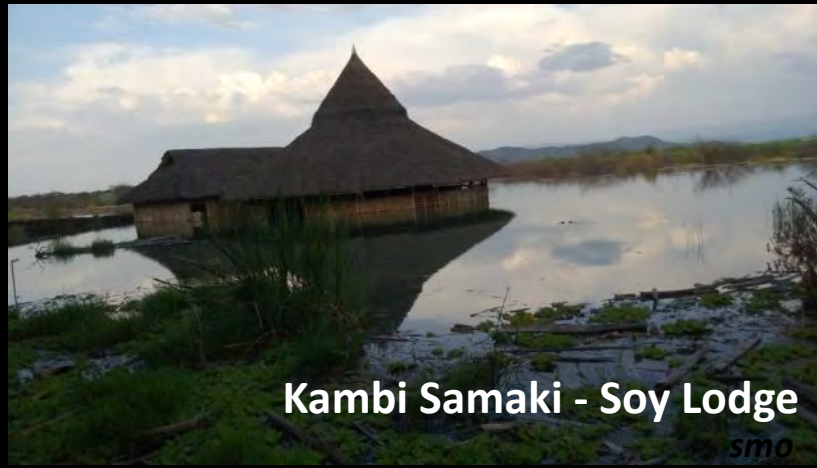
**Kambi Samaki - Soy Lodge**

**Impact on L. Baringo infrastructure, Tourism Resource and settlements**

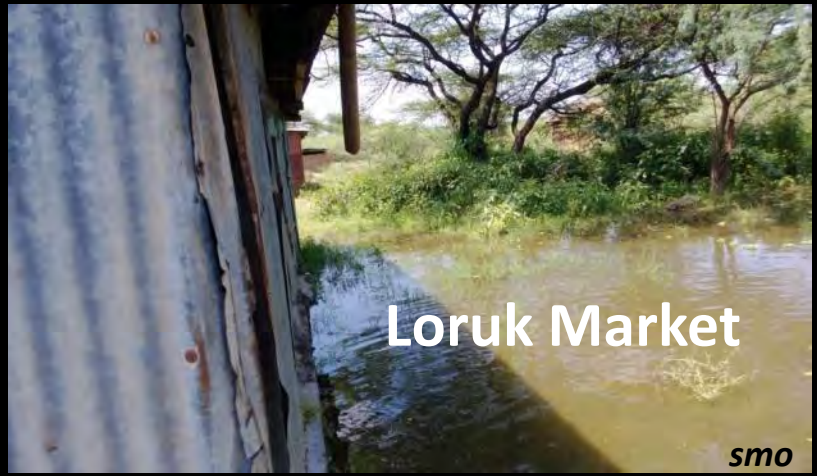
Loruk Market

## Impact on L. Baringo infrastructure, Tourism Resource and settlements
